Division of Oil, Gas and Mining

Inspection Report

Permit Number:	C0070020
Inspection Type:	PARTIAL
Inspection Date:	Wednesday, April 15, 2015
Start Date/Time:	4/15/2015 10:30:00 AM
End Date/Time:	4/15/2015 11:30:00 AM
Last Inspection:	Thursday, March 26, 2015

Site: **HORIZON MINE**

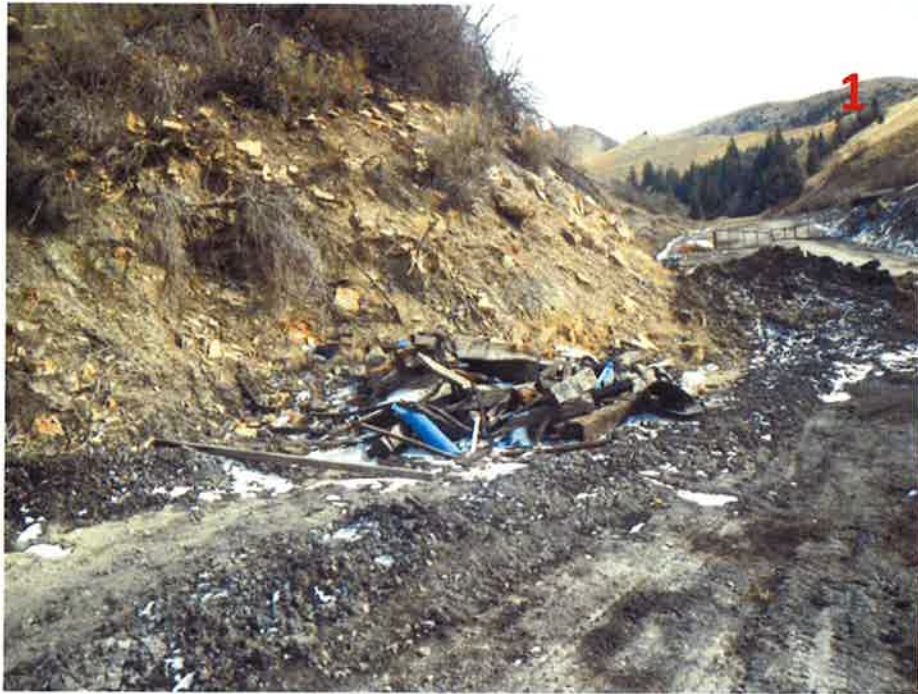
Noncoal waste is sitting in a pile on the lower pad. This waste should be disposed of properly to avoid enforcement action. This is visible in picture 1.

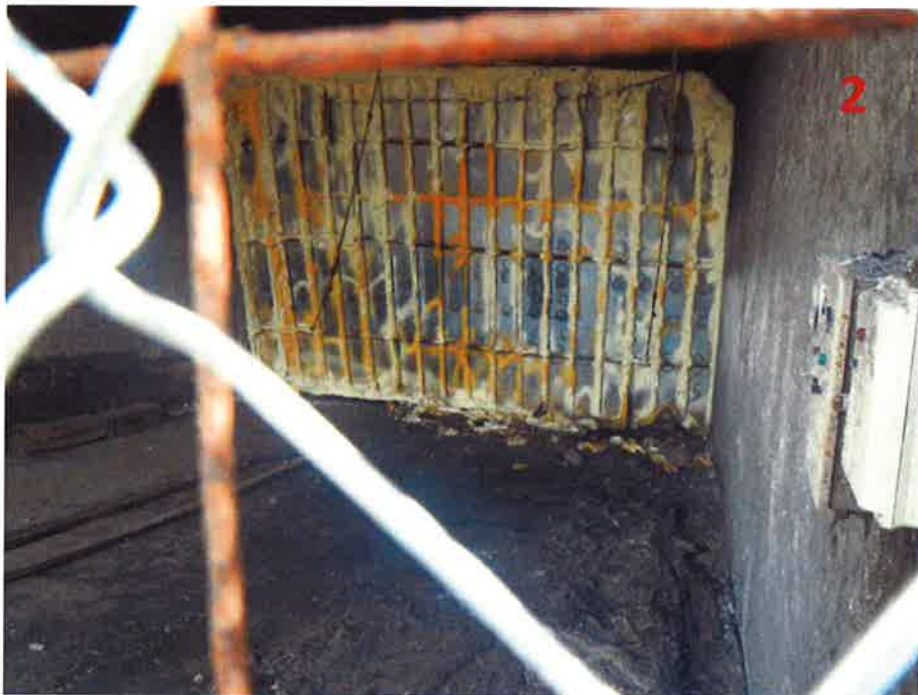
In the days prior to the inspection, the BLM and the Permittee notified the Division that vandalism had taken place in the #2 entry. The temporary stopping had been pulled down in what appeared to be an attempt to gain access to the mine. During the inspection on the 15th the stopping had been returned to its original function and appeared in-tact. This is shown in picture 2.

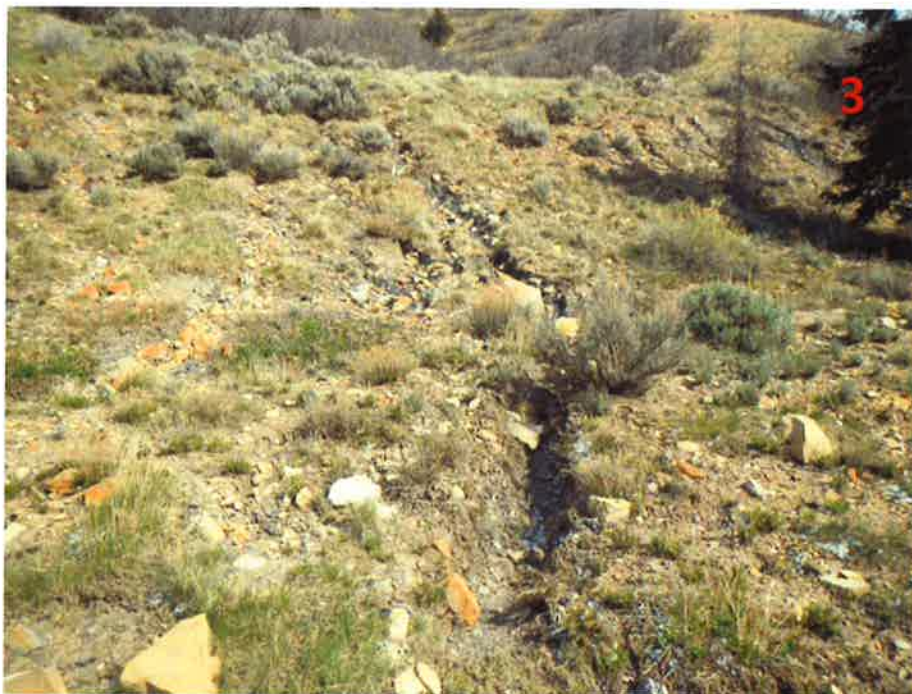
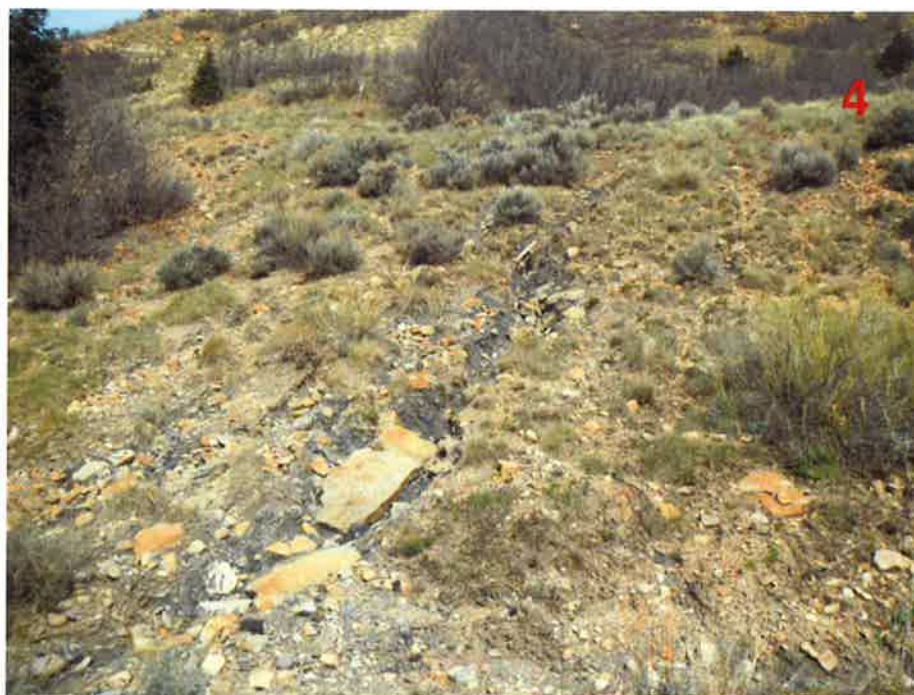
There are two large erosion rills forming in the area above the portal structures from runoff coming down the south facing slope and across the permit area. These rills should be repaired. Pictures 3 and 4 display this erosion.

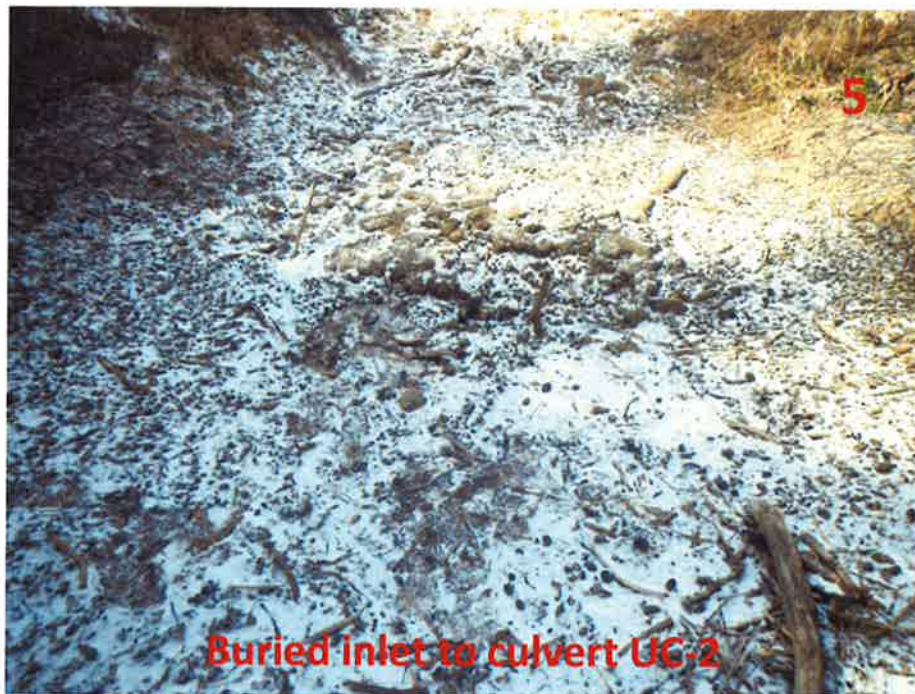
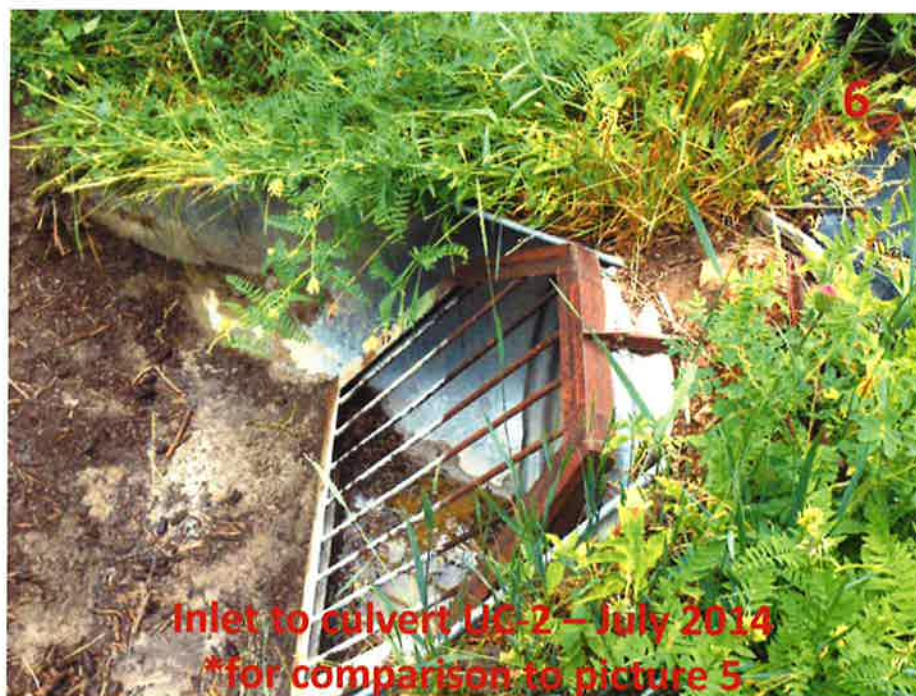
The inlet to culver UC-2 was completely buried. The inlet was not at all visible at the time of the inspection. This is a 36 inch cmp culvert used to divert undisturbed drainage from above the disturbed area. Picture 5 shows the culvert during the time of the inspection. Picture 6 is a picture taken at a previous inspection (July 2014) showing the culvert in a functioning state for comparison purposes.

The failure to maintain culverts resulted in the issuance of NOV #17150.

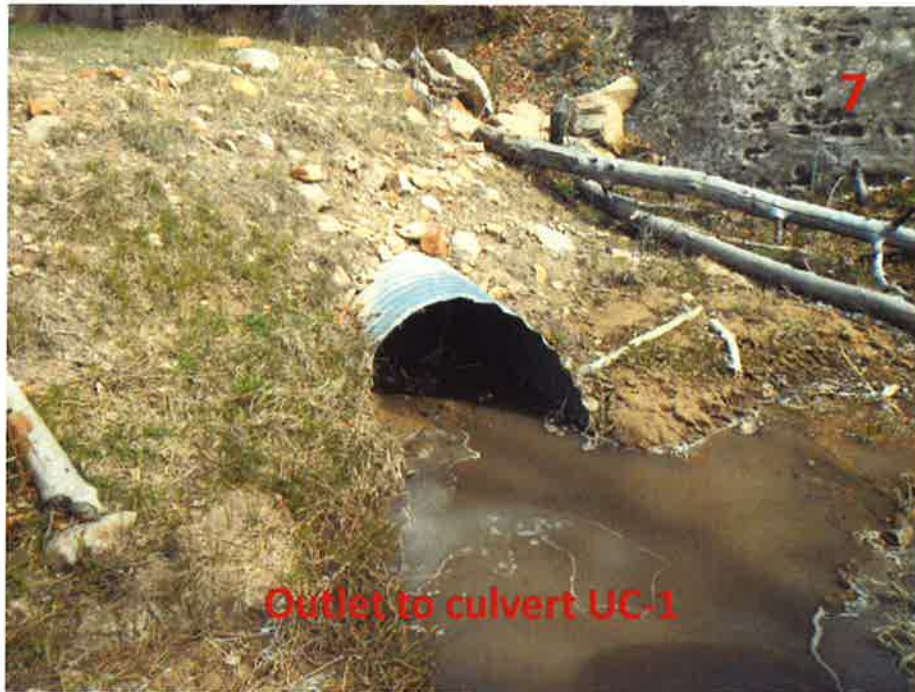
The outlet to UC-1 was half full of sediment. This is shown in picture 7.

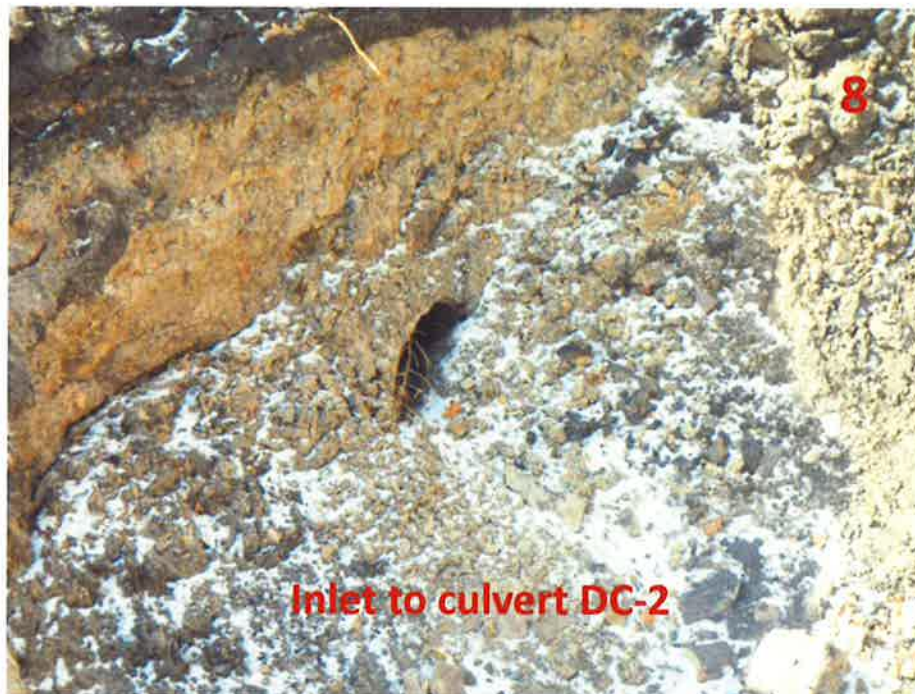
The inlet to culvert DC-2 was barely visible during the time of the inspection. As shown in picture 8.

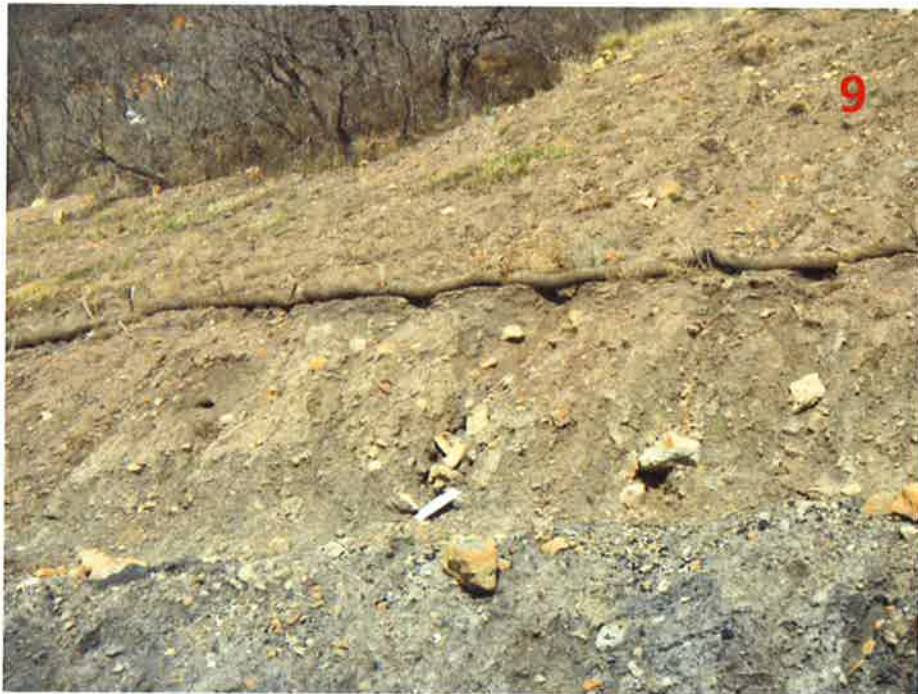
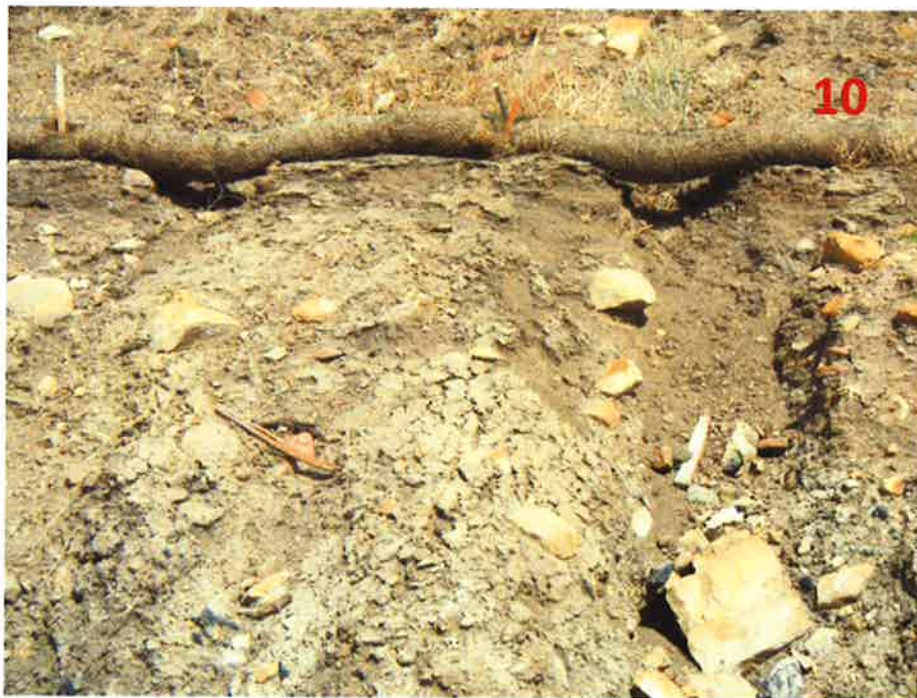
Topsoil stored in Area D as shown on Plate 8-1 of the MRP is experiencing significant erosion. The pile has not been maintained to keep the site stable and prevent erosion due to wind and rain. Pictures 9 and 10 show this. NOV #17151 was issued for this.

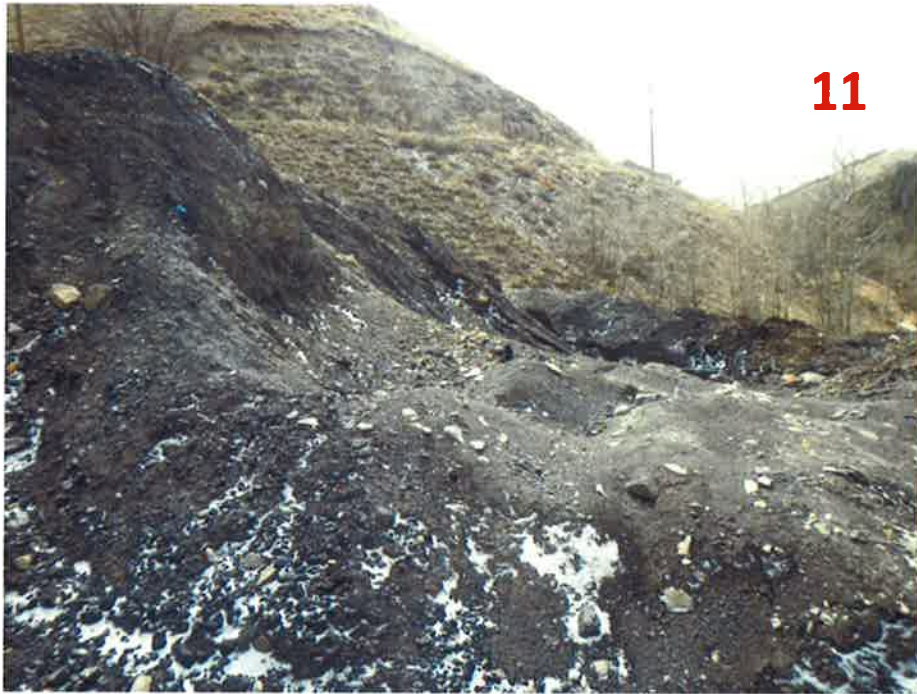
Piles of coal mine waste are still stored at the site, this is shown in picture 11. This waste should be properly disposed of in order to avoid enforcement action.

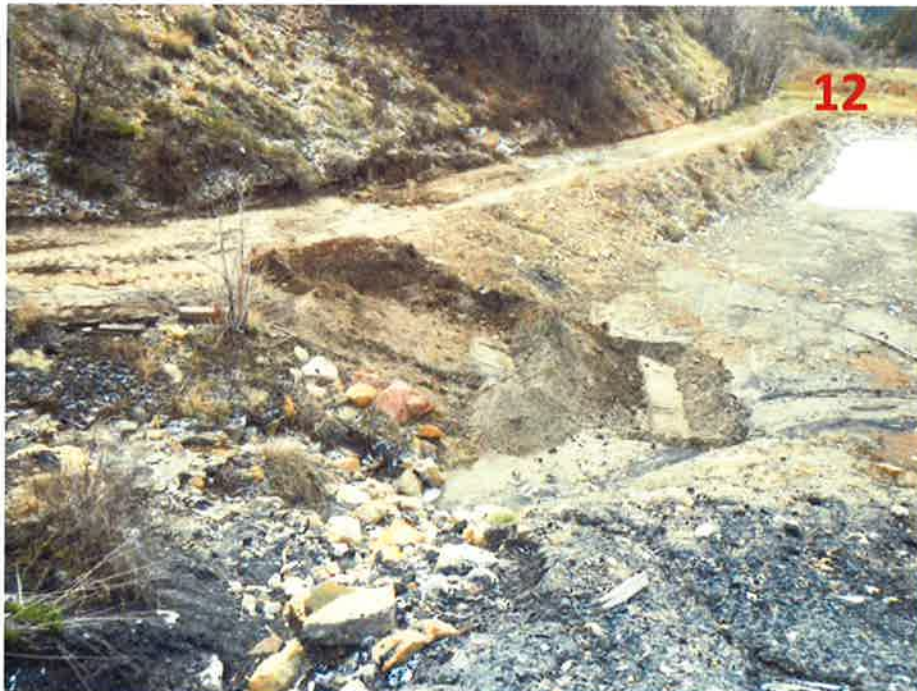
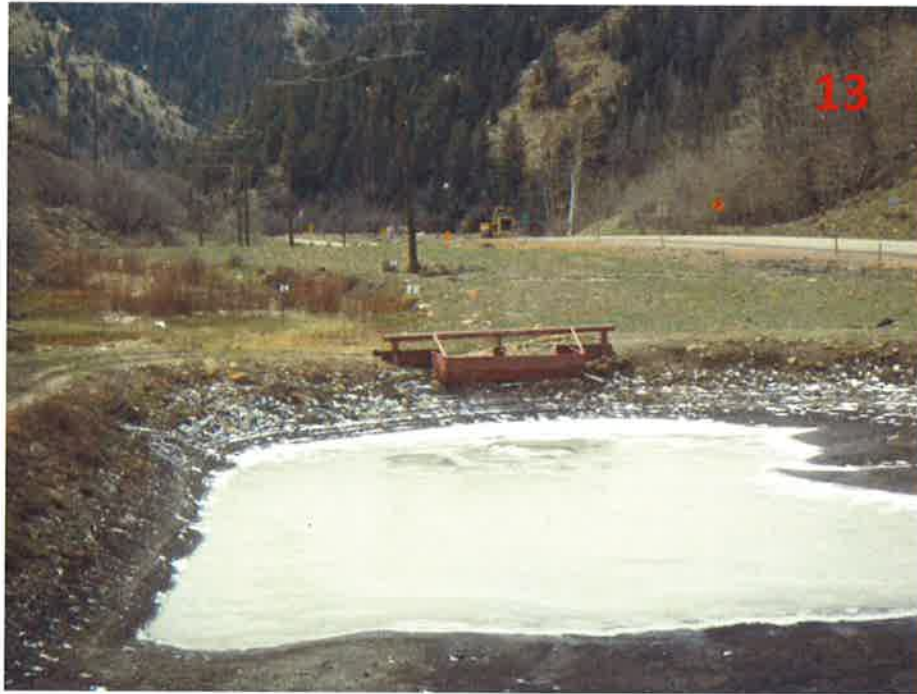
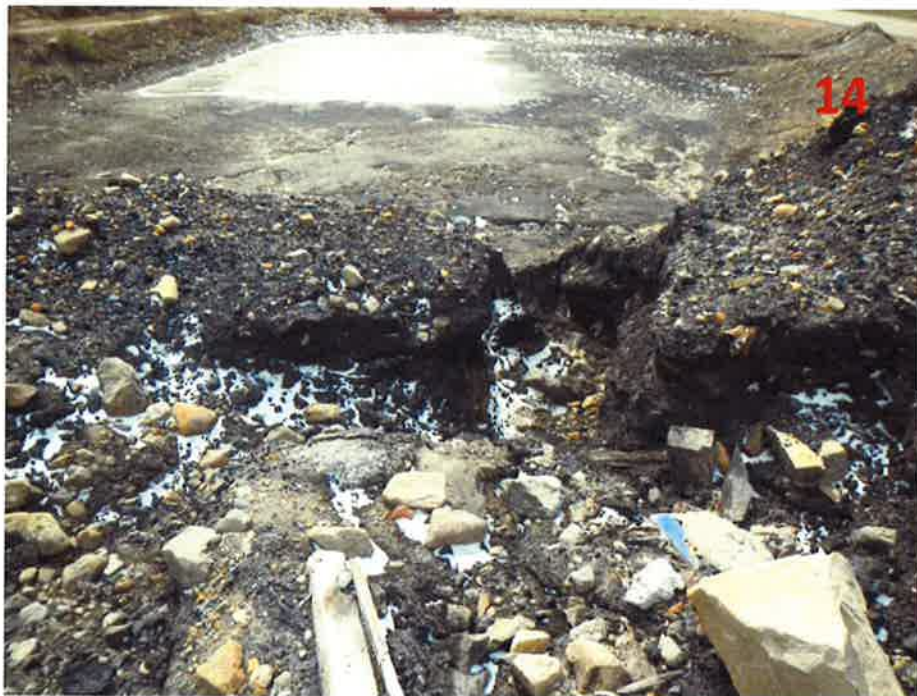
The pond does not meet the design standards as listed in the approved MRP.

A "failure to abate cessation order" (citation #12147) was issued on August 5, 2014 due to the failure to complete abatement work as perscribed in NOV #10141. The pond is in a continual state of disrepair, and there has not been any repair work done on the pond. The pond is mostly dry with a small amount of frozen water in the lowest point. The inlets and banks of the pond are continuing to erode. Pictures 12-14 display some of these problems.
